Case Report

A “Near-Miss Lethal Accident Case” in MR Suit of a Tertiary Care Hospital

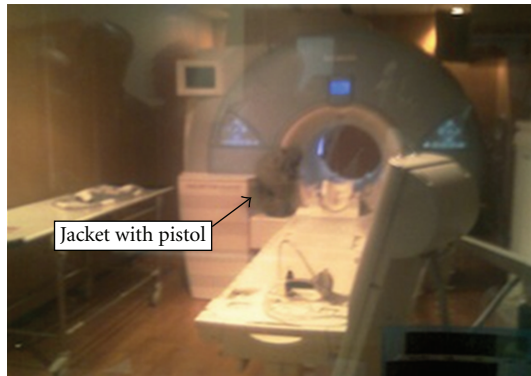
accompanying person wore a jacket with a pistol in the inside pocket, which was inadvertently forgotten and not removed. As a result when the patient's son neared the magnet, he felt a strong pull towards the magnet of the scanner. He was frightened and quickly pulled of his jacket which flew to the magnetic bore where it was lodged. The examination was abandoned at the time. Fortunately, the jacket could be removed along with the pistol by a careful and sustained pull, without quenching the magnet without damage to all the persons in the magnet room, computer room, or the equipment (see Figure 1). Otherwise, quenching the magnet would have been required as suggested by engineering department.

Accidents in the MR facilities have been reported in the literature and have occasionally proven lethal. According to a case report, a thumb locked firearm once discharged spontaneously in an MR section of a hospital [2]. Fortunately, none was injured and only minimal cosmetic damage occurred to the magnet. In the case under discussion, although the pistol of the officer was dual locked, the magnetic

FIGURE 1: Photograph showing jacket with pistol caught in the magnetic bore.

pull could have unlocked the pistol and a potentially fatal accident could have occurred. Chaljub et al. have presented cases of oxygen/nitrous cylinder turned projectile, accidents in the magnetic field vicinity of MR facilities [3]. These incidents resulted in huge financial liabilities, either as legal compensation to the patient (one patient sustained a facial fracture) or as repair and restoration of the MR equipment. These events which led to the near-miss accident in the tertiary care hospital are discussed hereunder and depicted in the Swiss Cheese Model (Figure 2).

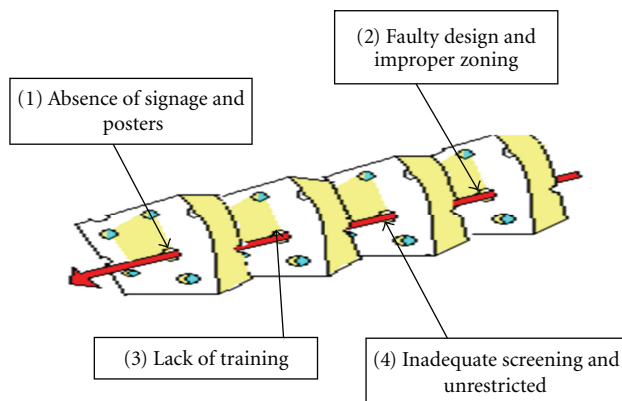
FIGURE 2: Swiss cheese model of the near-miss incident.

These were (a) faulty design and consequent improper zoning of the MRI section of the hospital, (b) unrestricted access of patients and their attendants, (c) incomplete screening partly due to (d) inadequate training of the personnel, including doctors and technologists, and (e) absence of signage and posters. When all the holes signifying the sequence of events lined up in the cheese, the “near-miss” incident occurred.

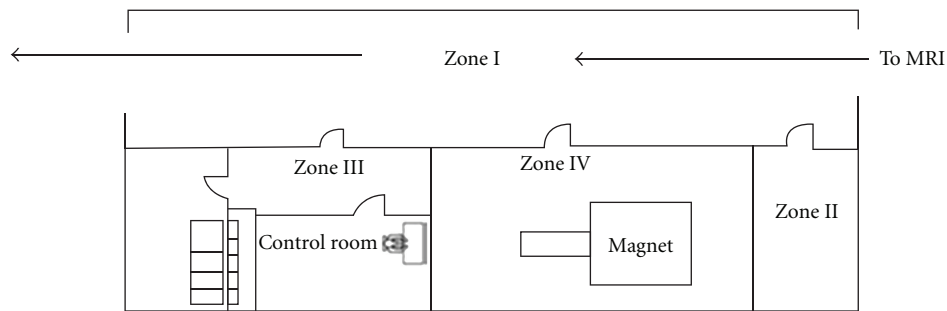
The design of the MRI facility of the hospital in which the near-miss event occurred does not conform to the standards. As a result, the zones of the facility lack a functional flow pattern. Entry to zone 4 (MR Scanner Room) directly opens to the corridor (zone I) of the Department of Radiodiagnosis and Imaging, through which patients and their attendants approach the CAT scan facility. Whenever the MR

scanner door opens, a potential catastrophe awaits as critical patients on portable oxygen cylinder traverse through this corridor while being taken for CT scan (Figure 3).

FIGURE 3: Floor plan of the MRI facility of the hospital.

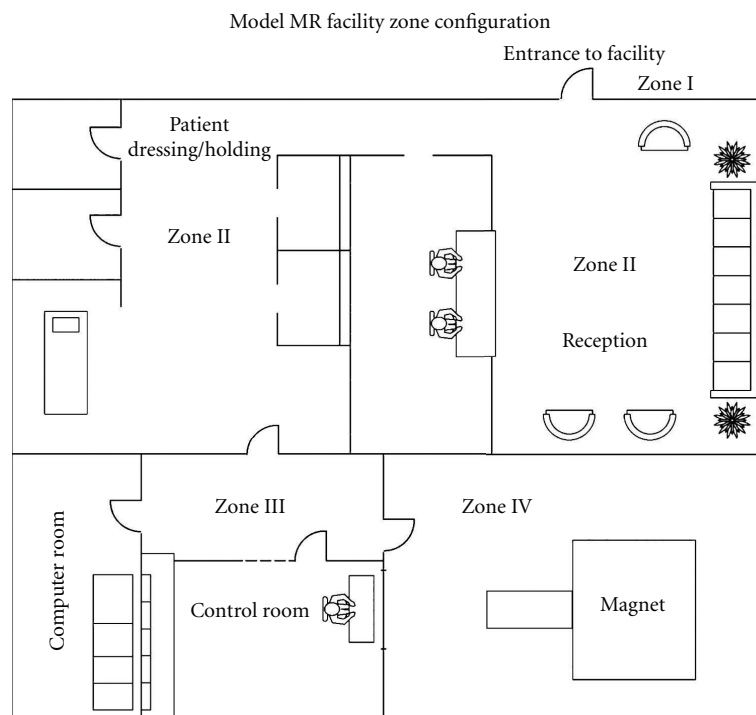
FIGURE 4: Idealized sample floor plan illustrates site access restriction considerations [1].

Incidents have been reported when oxygen cylinders turned into projectiles, once they were inadvertently brought into the vicinity of the magnetic field. One fatality, many injuries and damage to the magnet have thus been reported [3, 4]. According to the ACR Guidance Document for Safe MR practices: 2007, the facility should be designed so that proper zoning is maintained. The zones should have a functional relationship so that entry happens only from the lower to a higher zone (Figure 4).
